Navajo Abandoned Uranium Mine

Site Screen Report

**Mine Name: Arrowhead No. 2
Mine ID: 83**

August 2011

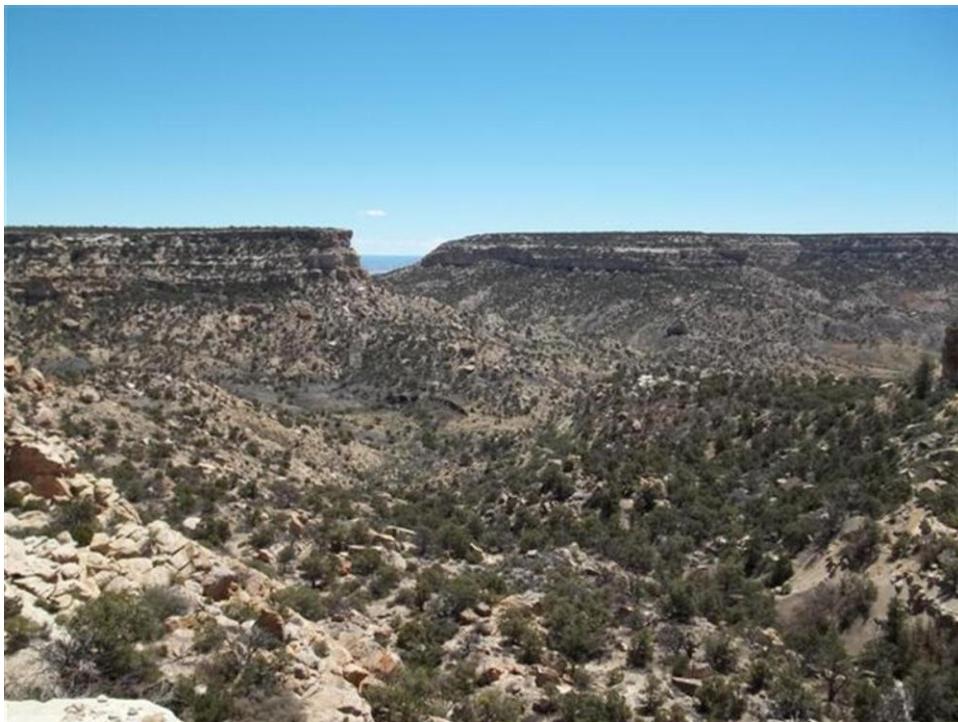
Photo 2: Mine Site #83; View from site

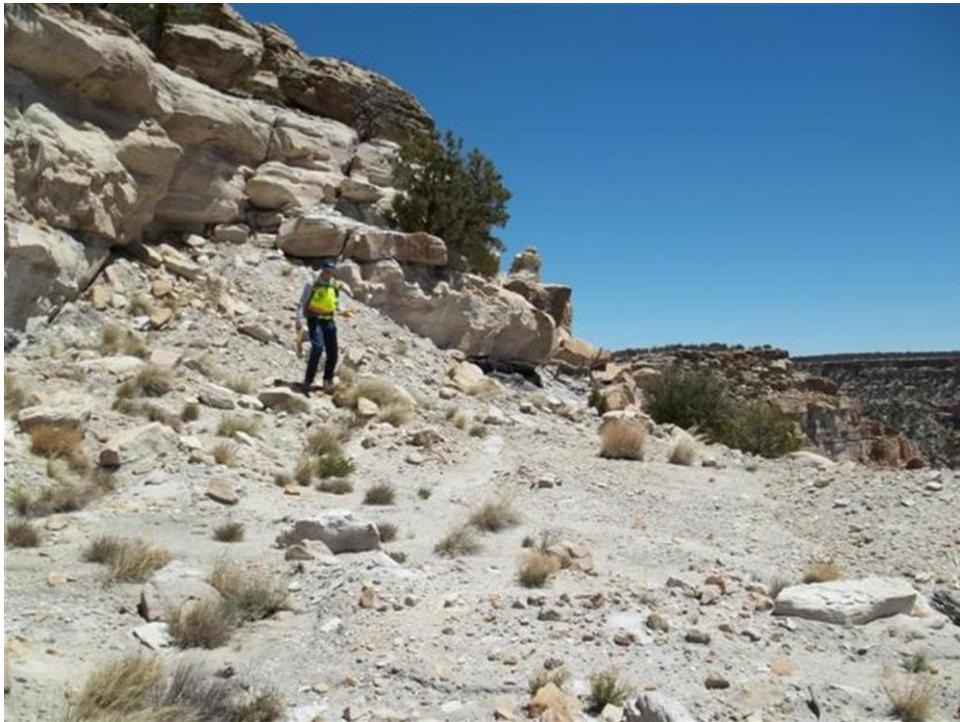
Photo 3: Mine Site #83; Bench below site

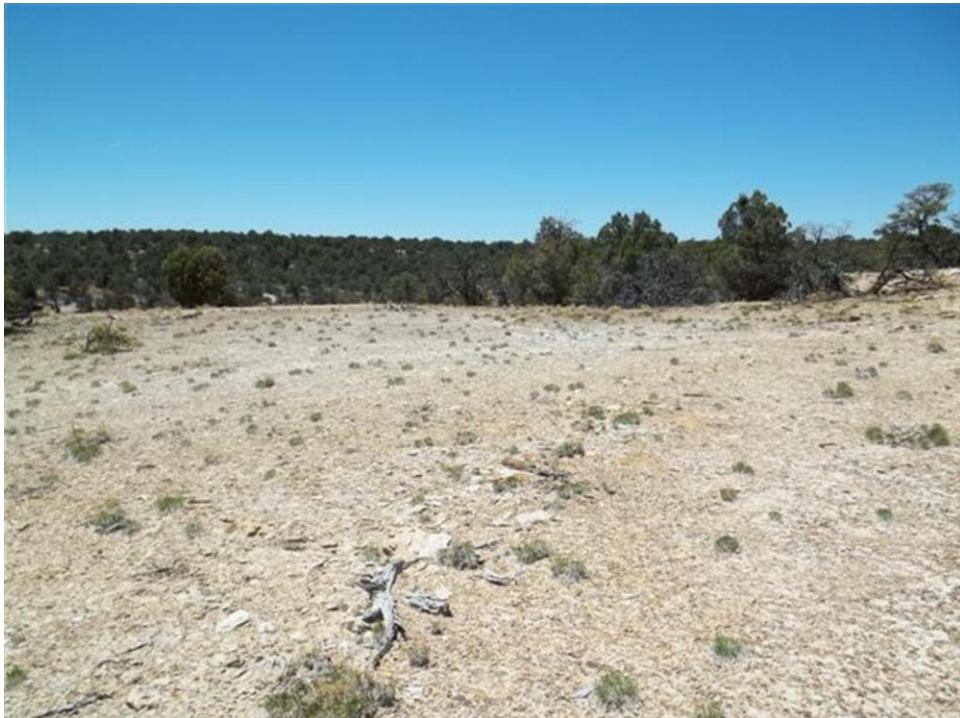
Photo 4: Mine Site #83; Top of site

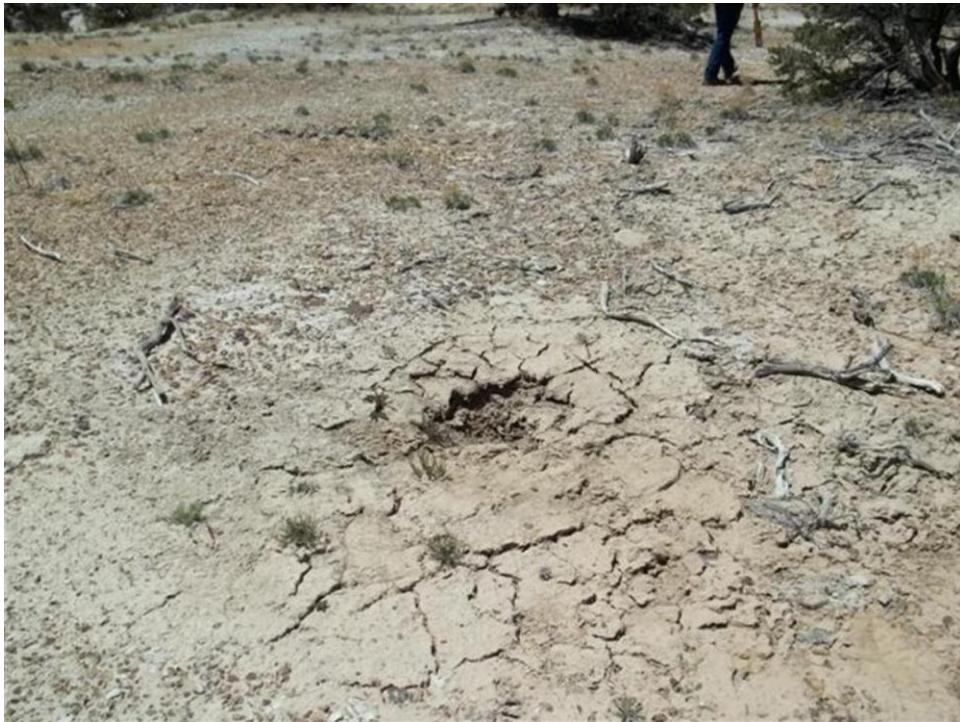
Mining debris (metal pipe driven into ground below mine); test/borehole in loose rock below mine; subsidence in ground that may be a borehole

Photo 5: Mine Site #83; Subsidence at possible borehole

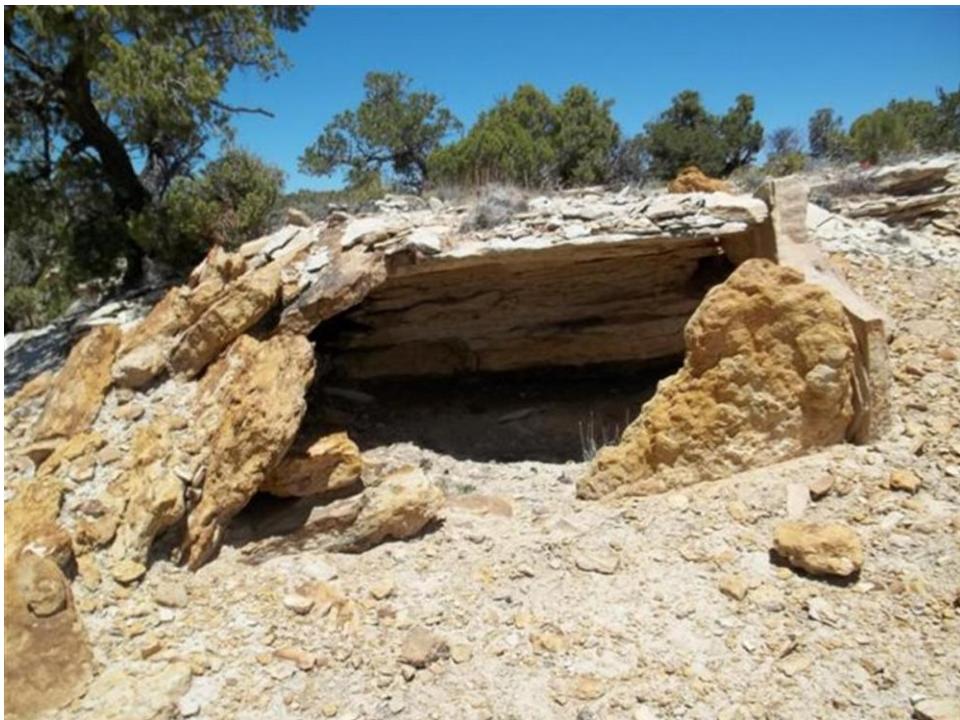
Photo 6: Mine Site #83; Shelter

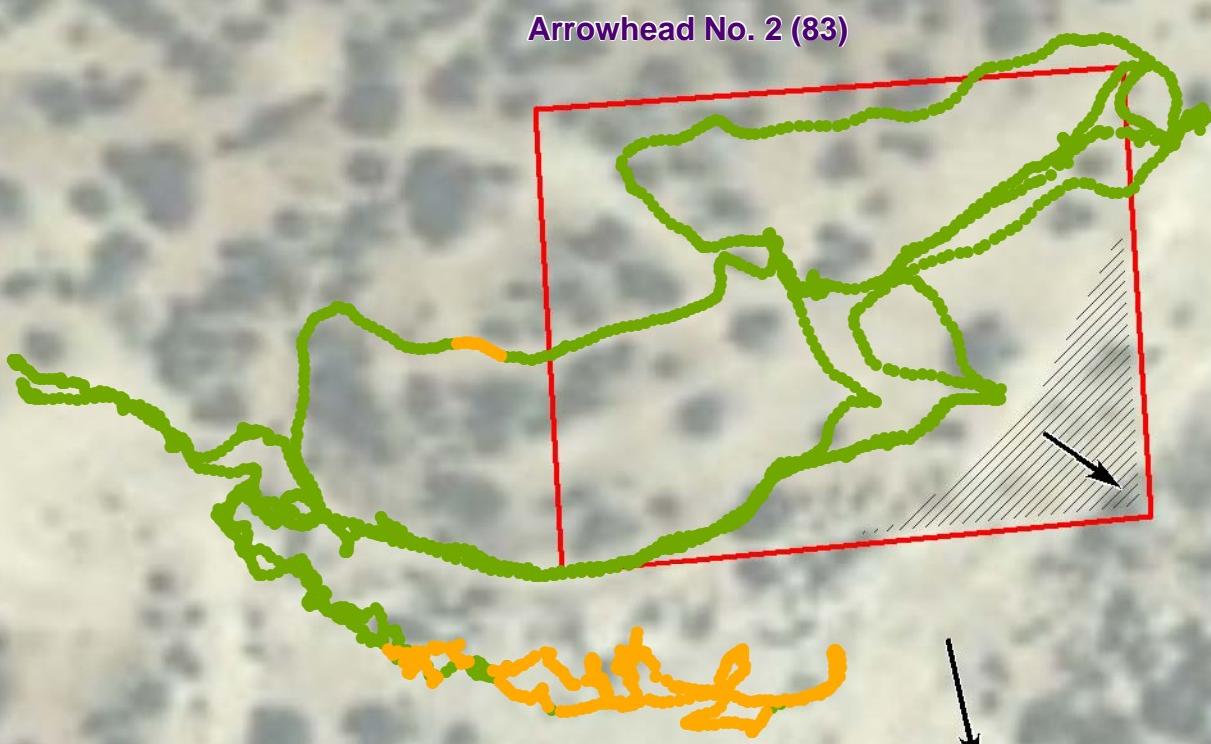
Figure 1 - Gamma Radiation Measurements, Above Two Times Background
Arrowhead No. 2 (83)
Tselani Chapter, Navajo Nation

A total of 2,003 gamma radiation measurements were collected from the mine site, ranging from 9,257 cpm to 112,683 cpm. The measurements are represented in Figures 1 and 2.
